Service Bulletin

MODEL: DSC-W830 No. E58409319

Subject: Compatibility information between SY board Date: Aug. 08. 2014

and MM flex board

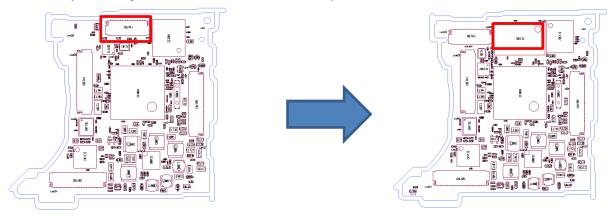
OLD SY board (PCB suffix -11)

Because of design change, it is impossible to assemble revised SY board and previous MM flex board, also revised MM flex board and previous SY board.

SY board layout changed and MM flex board connector position shifted because IC is discontinued.

In case you replace SY board or MM flex board, see below matrix and choose suitable pair of parts.
